## DYNAMIC TESTS OF AN ENERGY ABSORBING BARRIER EMPLOYING WATER-FILLED PLASTIC CELLS

70-08

**NO. M & R 636405-3**

November 1970  
M&R No. 636405-3  
Final ReportMr. J. A. Legarra  
State Highway Engineer

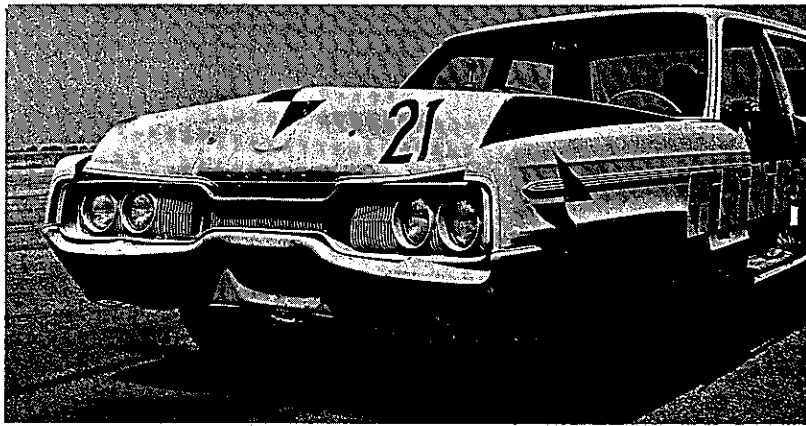
Figure 2

Results: See Plate 2 (page 14 ) for a summary of the test results. A 4680 lb. Dodge impacted the test barrier headon at a speed of 33.3 mph. The test vehicle did not stop quite as smoothly as it did for Test 211. Vehicle rise was 4-1/2 inches. Damage to the vehicle was moderate and included deformation of the grill, front bumper, and front of the hood (see Figure 2, below). The exhaust manifold was broken near its attachment to the engine block and the radiator was forced back into the V-belt lower pulley. The post behind the front door (removed for the test) on the drivers side failed at its connection with the roof (see Figure 3, below). The permanent deformation of the steering wheel was 2" (see Figure 4, below).

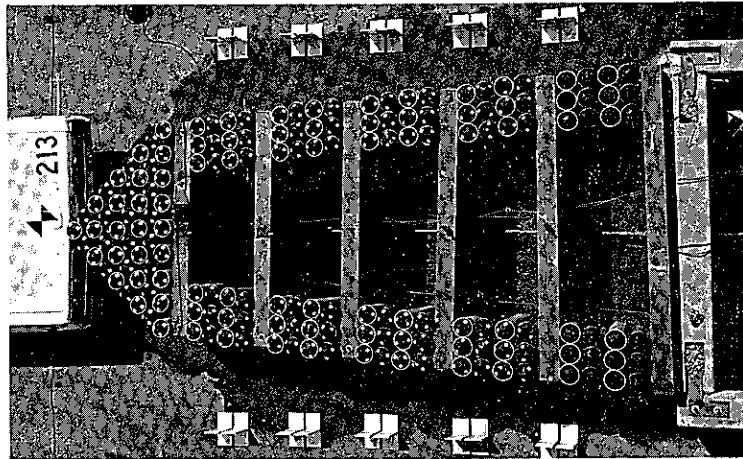
Figure 6

Barrier Description: The test barrier used was identical to that used for Test 211 and 212 with the following exceptions: (1) a triangular shaped cell-cluster was used on the nose of the barrier; (2) the back row in this cluster had alternate full and empty cells; (3) some cells had water in their upper portion only; (4) overall barrier length was increased to 16'-3"; (5) evaporation caps were removed from all the cells in the barrier; and (6) the number of orifices in some of the rear cells was increased (see Figure 6, below). The total number of cells in the barrier was 165. See Exhibit 3 for additional details of the test barrier.

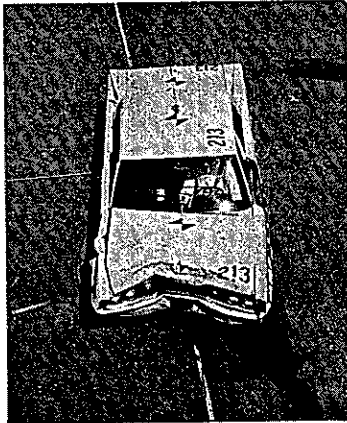
Figure 7

Results: See Plate 3 (page 18 ) for a summary of the test results. A 4600 lb. Dodge impacted the test barrier headon at a speed of 48.2 mph. During impact, the vehicle rode up on the barrier nose. Vehicle rise was 11 inches. The vehicle fan and radiator were jammed up against the engine block. There was severe damage sustained by the grill, front bumper, and front of the hood of the test vehicle (see Figure 7, below). The body of the vehicle was deformed over the door post and in front of the front door hinges on both sides, indicating a severe buckling failure of the vehicle chassis (see Figure 8, below). There was severe buckling of the right front fender

and minor buckling of the left front fender. There was moderate buckling of the floor board in the rear of the passenger compartment. The impact force of the dummy, restrained by both a lap belt and single diagonal shoulder harness, caused a 2-1/2 inch permanent deformation in the steering wheel. The driver's seat came loose on its guides although the guides remained firmly attached to the floorboard. There was some fraying of the shoulder harness near its connection to the lap belt. The vehicle was considered a total loss.

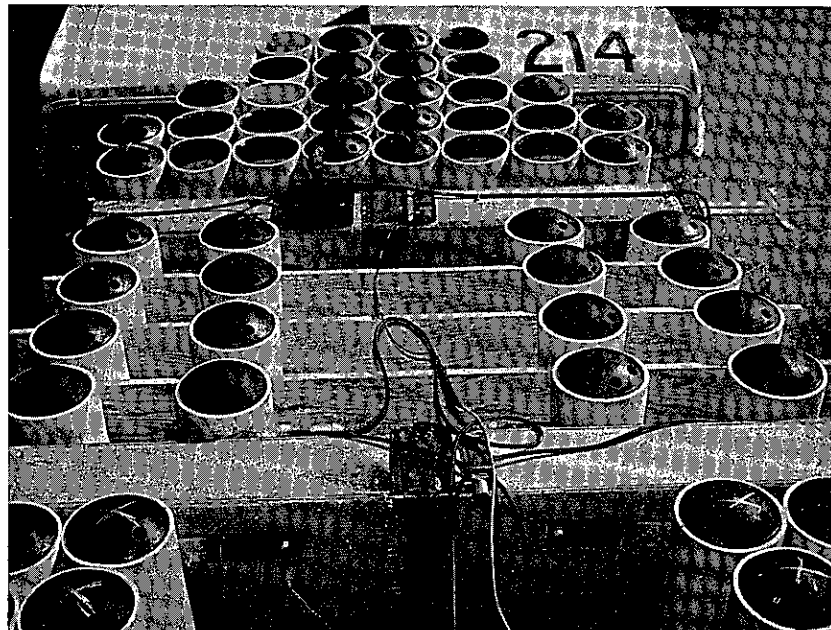
Figure 10

Barrier Description: Additional barrier modifications were made due to the severity of the impact in Test 213. The first three diaphragms were replaced with fiberglass coated plywood hollow core structures. Honeycomb paper was placed in the core to obtain a more rigid structure. A significant weight reduction (28%) in the first three diaphragms was thus realized while maintaining approximately the same rigidity. Another significant change was the use of a "sandwich" arrangement of cells and 5/8" plywood panels between Diaphragm Nos. 1 and 2 (see Figure 10, below). This arrangement was used to further decrease the mass of the barrier nose and to obtain better efficiency from the water cells placed between the leading diaphragms. The water in the nose cells was centered at the cell mid-height. The water in all the other cells was in the top portion. There was a total of 150 cells in the barrier, many of which did not contain water. See Exhibit 3 for additional barrier details.

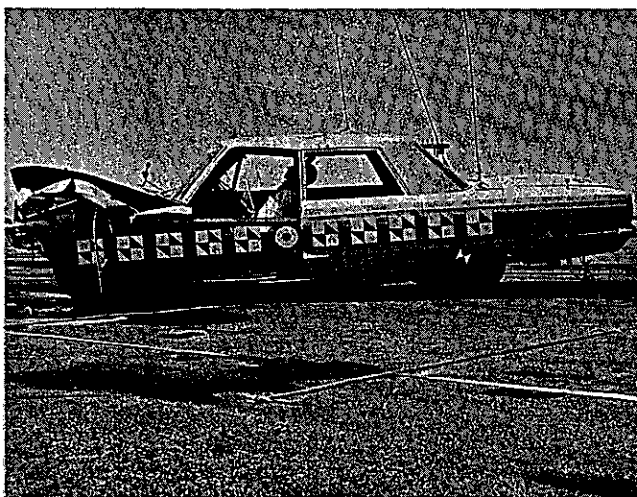
Figure 11

The following vehicular damage was sustained. The fan and radiator were jammed up against the front of the engine block, which appeared to be displaced slightly to the rear. There was severe damage to the grill, front bumper, and front of the hood of the test vehicle. The body of the vehicle buckled over the door posts and in front of the front door hinges on both sides, indicating severe buckling of the vehicle chassis. There was severe buckling of the left front fender and minor buckling of the right front fender. Maximum deformation of the front of the vehicle was 2 ft. (see Figure 11, below). There was some displacement of the dashboard into the passenger compartment and 4-1/2 inches of steering column projection into the passenger compartment. The impact force of the dummy caused a 3-3/4 inch permanent deformation in the steering wheel (see Figure 12, below). Stitching of the diagonal shoulder harness frayed near the connection of the shoulder harness to the lap belt.

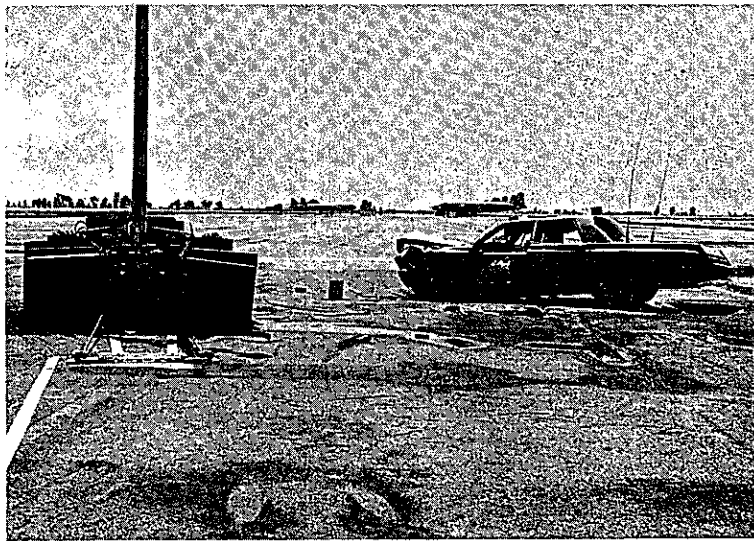
Figure 21

Results: See Plate 6, page 31, for a summary of the test results. A 1968 Dodge impacted the barrier headon at a speed of 57.5 mph. As rearward displacement of the barrier began, the fender panels rotated downward such that their lower rear corners penetrated into the asphalt concrete runway and restricted backward movement of the barrier. This, plus an 18 inch vehicle offset at impact, resulted in a lifting, rolling motion being imparted to the test vehicle. The vehicle traversed a 360° roll off to the right side of the barrier and came to rest several feet behind and to the right of the barrier (see Figure 21, below). Front end crush varied from 0 to 20 inches; maximum crush was on the left side (see Exhibit 8). The top caved in, the windshield was broken, the left rear wheel was bent, the left rear door jammed, and there were scrapes over much of the surface of the vehicle. However, off-center impacts on any barrier nose may inherently cause this type of vehicle instability due to the unsymmetrical rise of the vehicle fore-structure. There was no measurable deflection of the collapsible steering column.

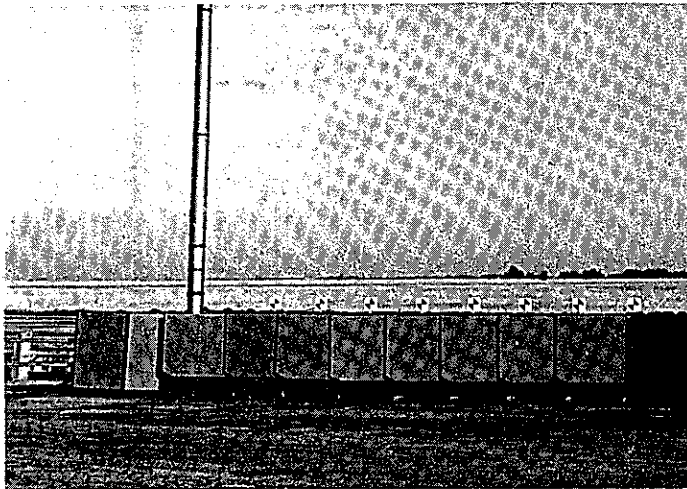
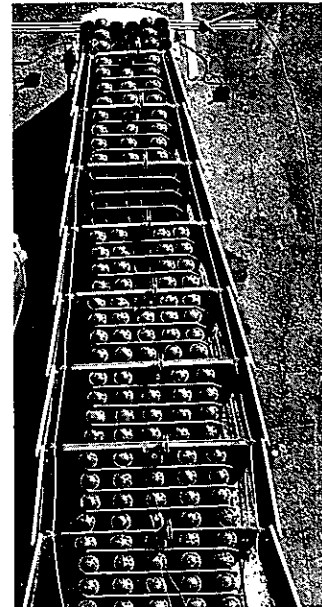
Figure 24

**Barrier Description:** Modifications to the barrier used for Test 215 included cutting off the lower six inches of all the fender panels and cutting the lower rear corner of the panels on a diagonal to eliminate penetration of these trailing corners into the runway as occurred during Test 215 (see Figures 24 and 25, below). Also, metallic shoes (or skids) were added to the lower edge of interior panels, heavier hinges were used to attach the fender panels to the diaphragms, and all the evaporation flaps were removed to lessen, at least to some extent, the lateral discharge of the water and danger of loss of telemetry signal.

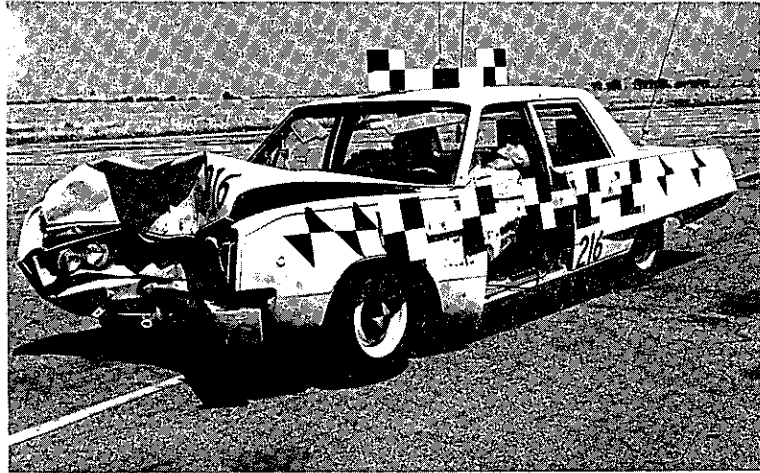
Figure 26

The maximum crush of the vehicle forestructure was 20 inches and occurred at the center of the vehicle (see Exhibit 8 and Figure 26, below). Buckling of the car body was indicated by a crimp in the roof over the door post on both sides of the car. The engine deflected the metal firewall back 1-2 inches. Steering wheel deformation was 1-1/4 inches. The steering column collapsed 2.9 inches. (There were collapsible steering

columns in the 1968 Dodges used for Tests 215 through 218; however, there was no measurable collapse of them except in the vehicle used for this test).

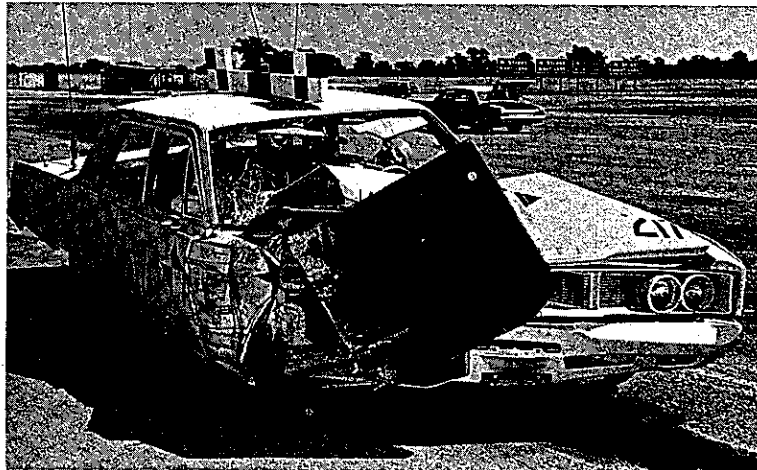
Figure 28

Results: Plate 8, page 39, contains a summary of the test results. A 4760 lb. 1968 Dodge impacted along the side of the barrier ten feet behind the barrier nose at a speed of 57.0 mph and an angle of 9°. After the vehicle struck the barrier, it was slightly redirected by the barrier fender panels. However, significant redirection was not achieved until the solid resistance of the bridge approach guardrail was utilized. There was virtually no rise of the vehicle forestructure. The right front side of the car was severely crushed; there was no crush on the left side. (See Figure 28, below, and Exhibit 8). The right front door was damaged and jammed and the right door post was partially torn loose at the roof connection. The right side of the hood cracked the windshield. Near the end of the collision, the right rear quarter panel of the car slapped the barrier. This damaged the right rear fender and the right end of the rear bumper. A crimp in the roof over the door posts was sustained on both sides of the car; the radiator was buckled back toward the engine on the right side. The steering wheel had a slight deformation but the steering column did not collapse.

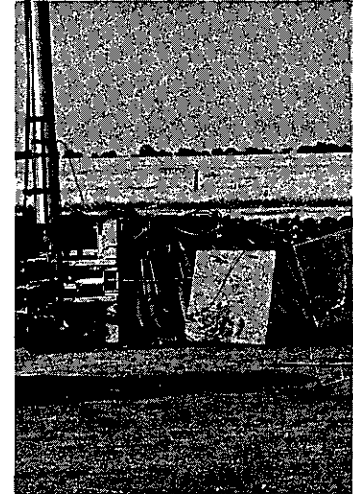
Figure 30

Several fender panels were torn off the barrier on the left side, mainly due to hinge failures. Two panels were thrown 8'-0" beyond the final position of the car and two panels were lodged in the crushed front end of the car. The five cells on the left side

of the bridge approach guardrail were all torn off and scattered along the path of the car. Shear pins in the secondary cables sheared off. Permanent displacement of the barrier nose was 1.5 feet (see Figures 29 and 30, below).

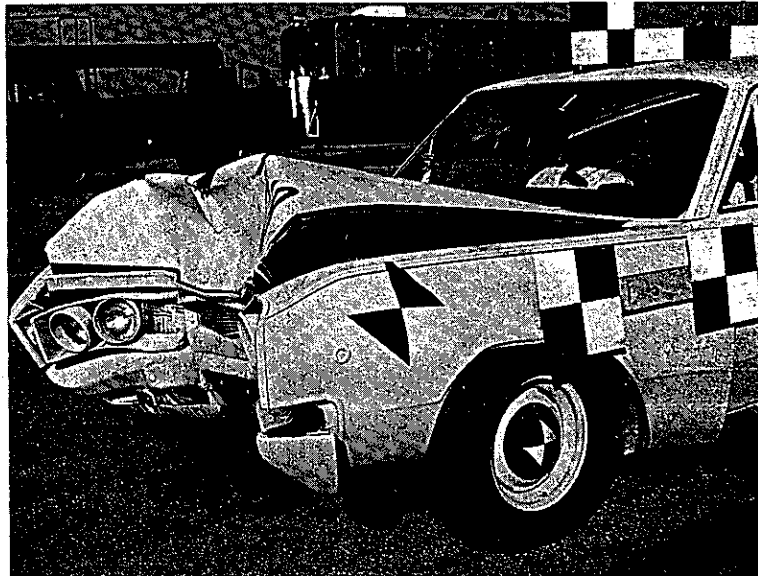
Figure 31

Results: Plate 9, page 43, contains a summary of the test results. A 4760 lb. 1968 Dodge impacted the nose of the barrier at an angle of  $8^{\circ}$  and a speed of 59.2 mph. The vehicle struck the barrier, rotated until it was nearly on line with the barrier axis, and continued to a stop in a manner similar to that of Test 216 (62 mph headon impact). The crush in the vehicle forestructure formed an arc (plan view) with least crush at the fenders. Maximum crush at the center was 19 inches (see Figure 31, below, and Exhibit 8). Once again, a crimp was noted in the roof over the door posts on both sides of the car. The left front door was jammed and the radiator buckled back towards the engine. Vehicle rise was 1'-4".
